CALSPAN ON-SITE AIR BAG DEPLOYMENT INVESTIGATION

CALSPAN CASE NO. 95-20

**VEHICLE #1 - 1994 CHEVROLET CAMARO Z28 CONVERTIBLE
(DUAL AIR BAG-EQUIPPED)
LOCATION - UTAH
CRASH DATE - [REDACTED] 1995**

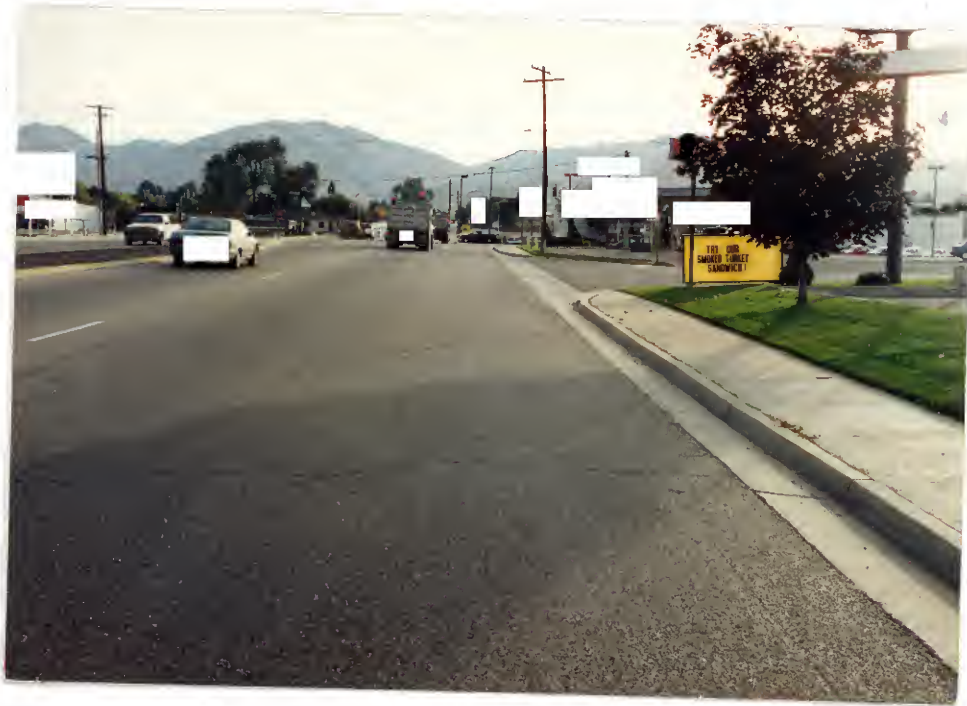
1. View of Vehicle #1's trajectory (1994 Chevrolet Camaro Z28 convertible) eastbound on a four divided highway prior to making a right turn into an intersecting local street. This view was taken 22.9 m (75.0') prior to the driveway of the restaurant.

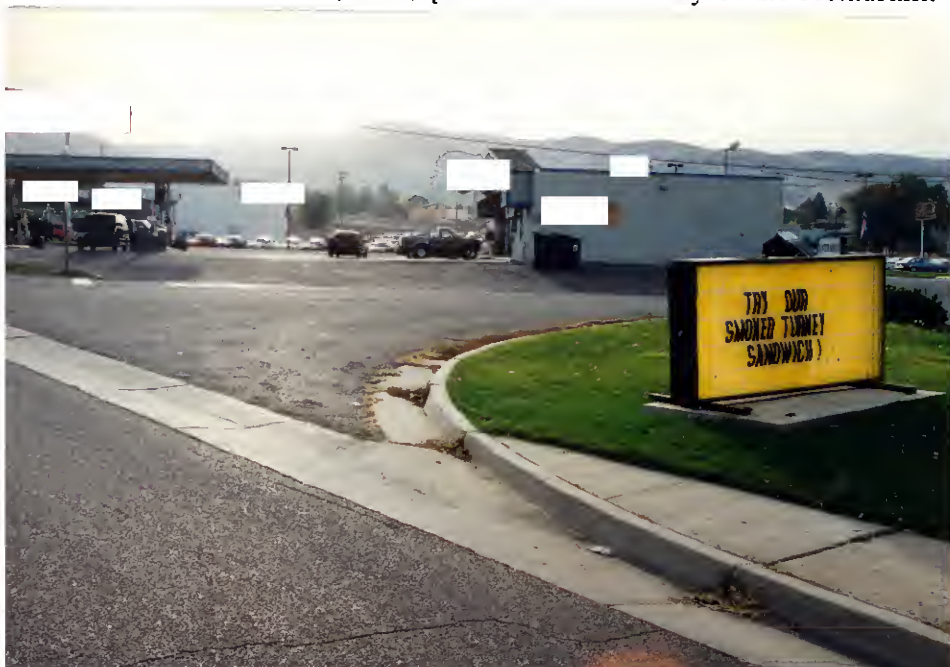
2. View of Vehicle #1's trajectory eastbound on the four divided highway at the intersection with the local street 15.2 m (50') prior to the restaurant driveway.

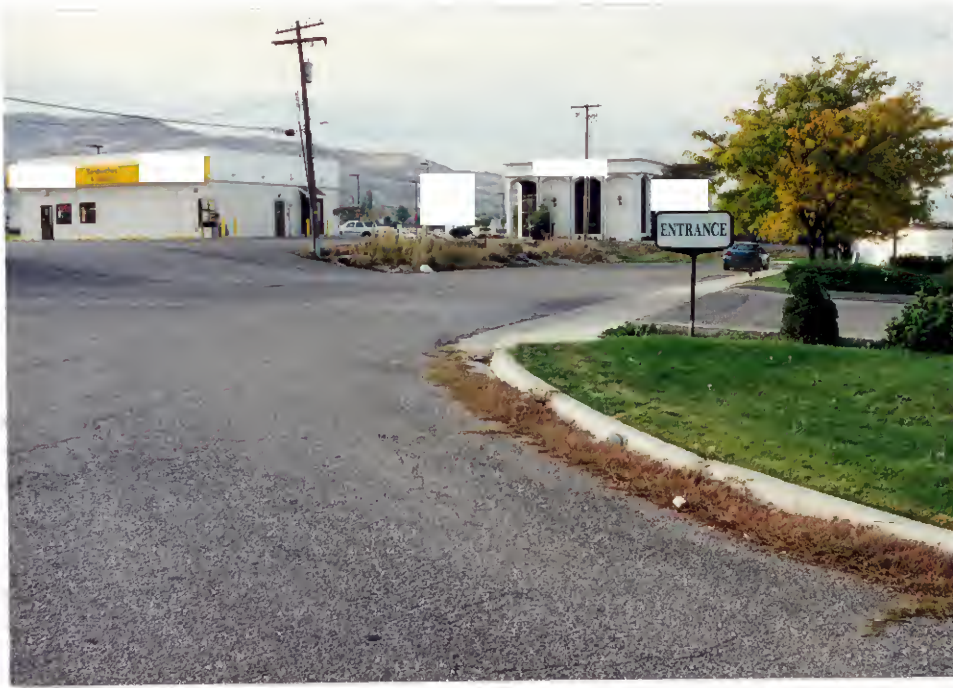
3. View of Vehicle #1's trajectory at the junction of the local roadway and restaurant driveway.

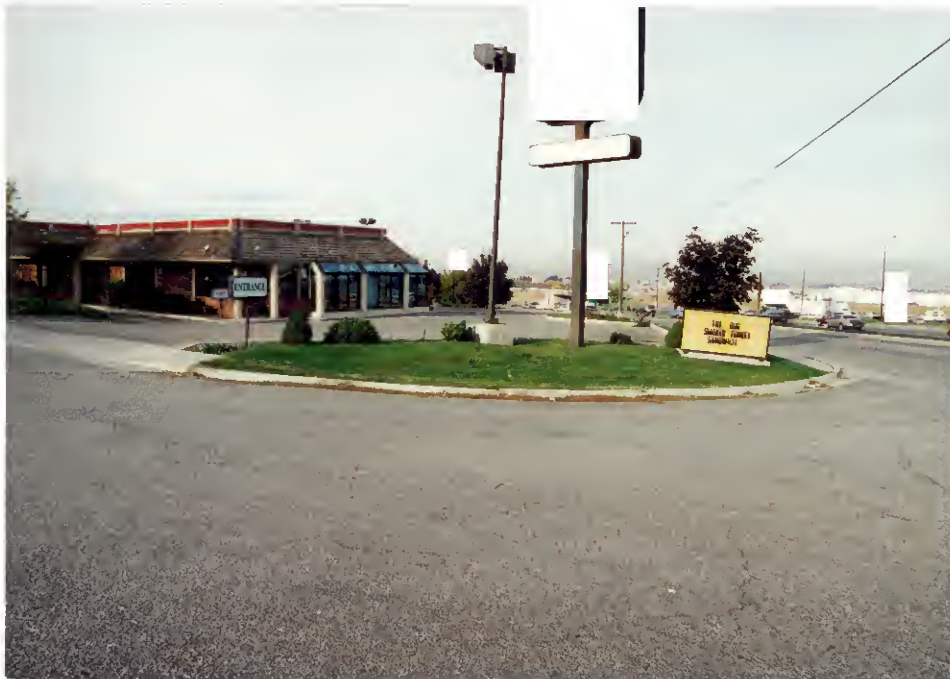
4. Look back view of Vehicle #1's trajectory showing the over all approach to the restaurant.

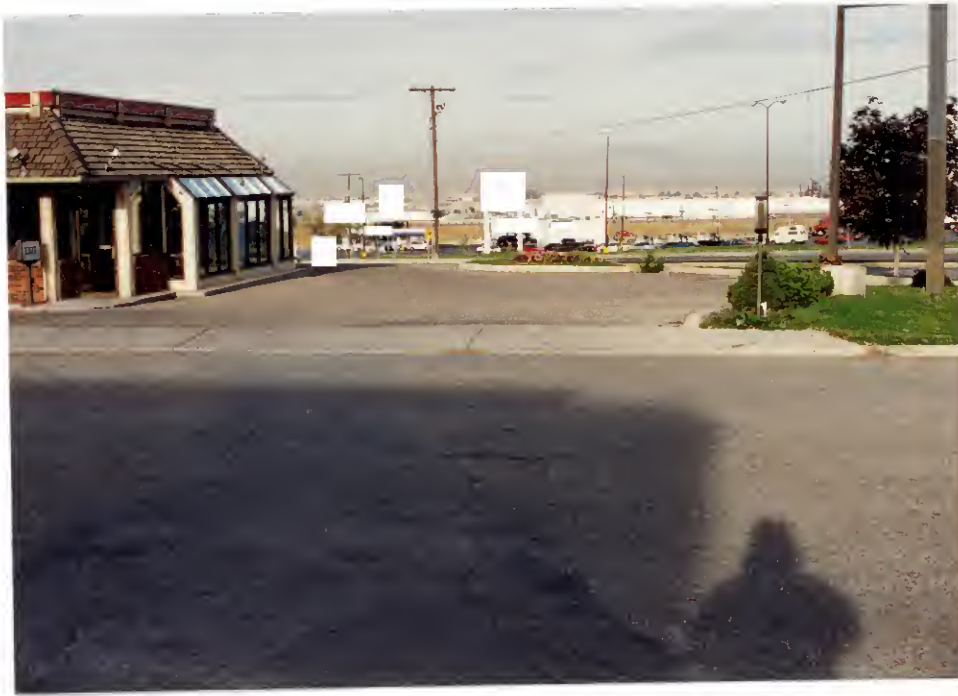
5. Another view of Vehicle #1's trajectory into the restaurant driveway.

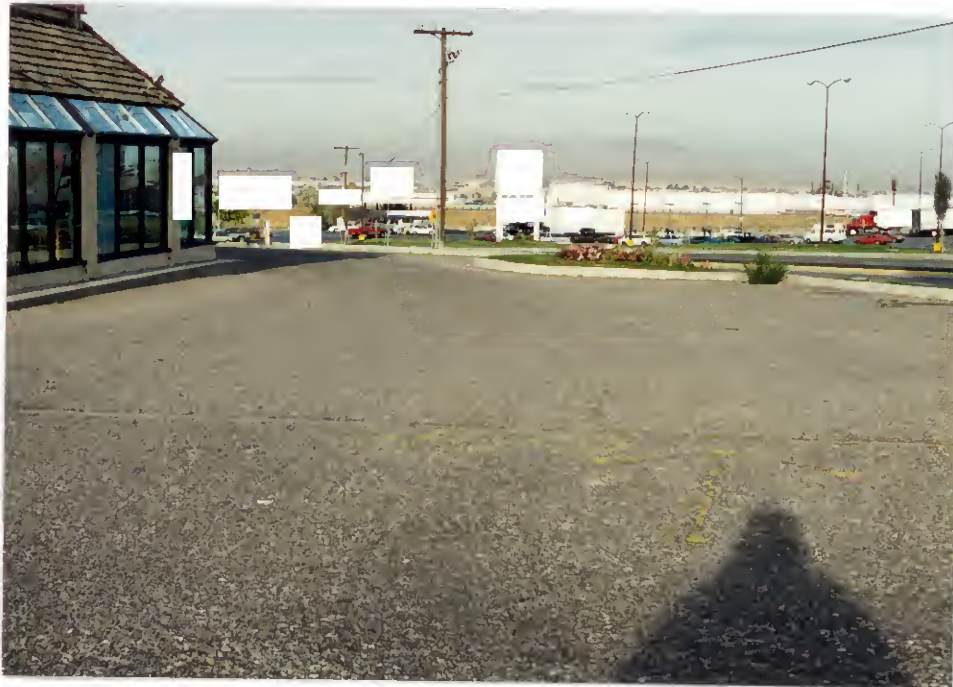
As the driver entered the restaurant property, she slowed down almost to a stop due to the spillway (i.e., dip) across the apron of the driveway. At this point, the vehicle was 45.7 m (150.0') from the POI. As the vehicle traveled past the front of the restaurant, the driver was looking to her left in search of a parking space. She observed that two parking spaces were vacant adjacent to the outdoor eating area at the northwest corner of the fenced area. The position of her head was verified by the injury she sustained to the right side of her face and neck from contact with the deploying driver side air bag. She made a left turn and struck the parking lot island curb.

6. Trajectory of Vehicle #1 - 45.7 m (150.0') prior to the point of impact (POI).

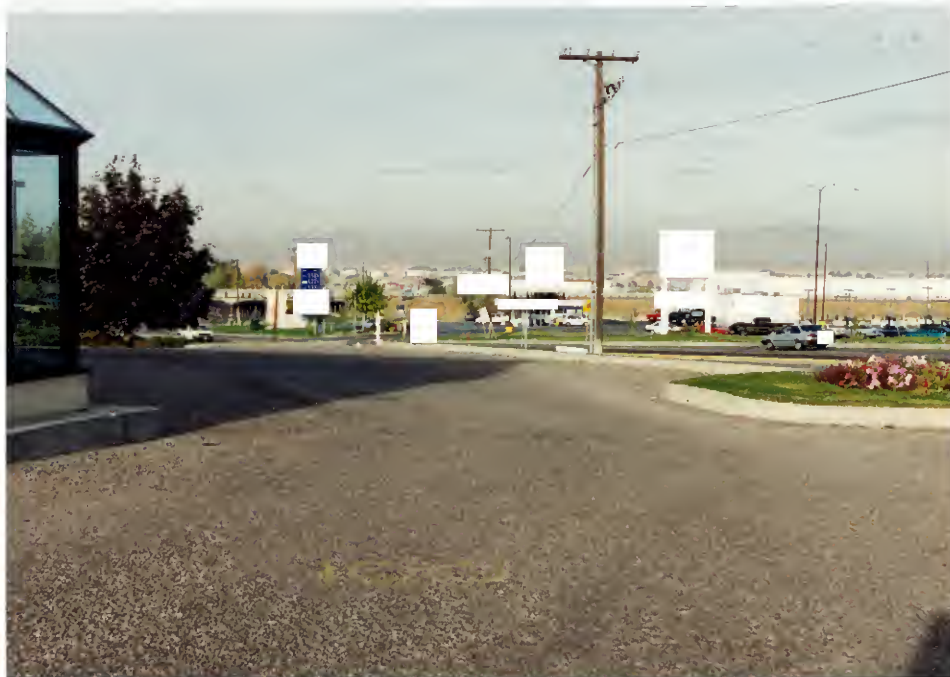
7. Trajectory of Vehicle #1 - 30.5 m (100.0') prior to the point of impact (POI).

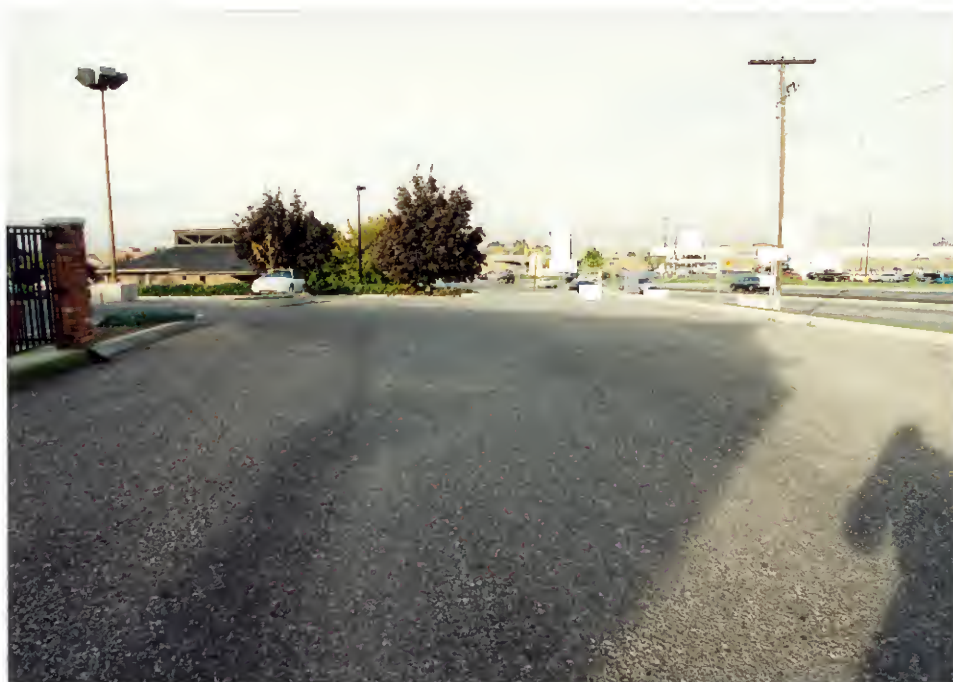
8. Trajectory of Vehicle #1 - 22.9 m (75.0') prior to the point of impact (POI).

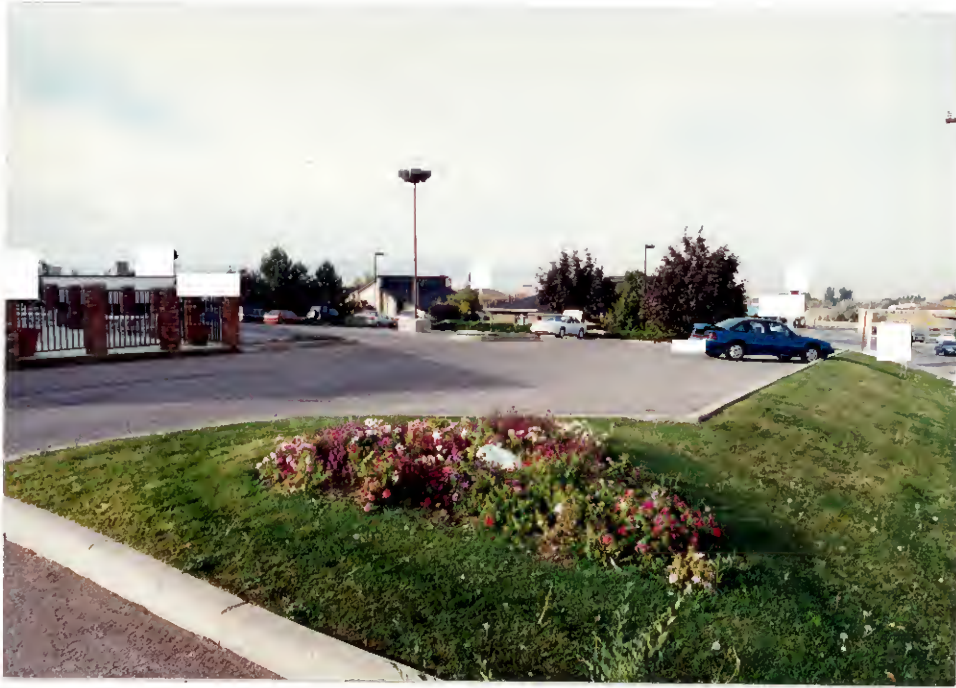
9. Trajectory of Vehicle #1 - 22.9 m (75.0') prior to the point of impact (POI) as viewed from between the four lane divided roadway and the restaurant driveway.

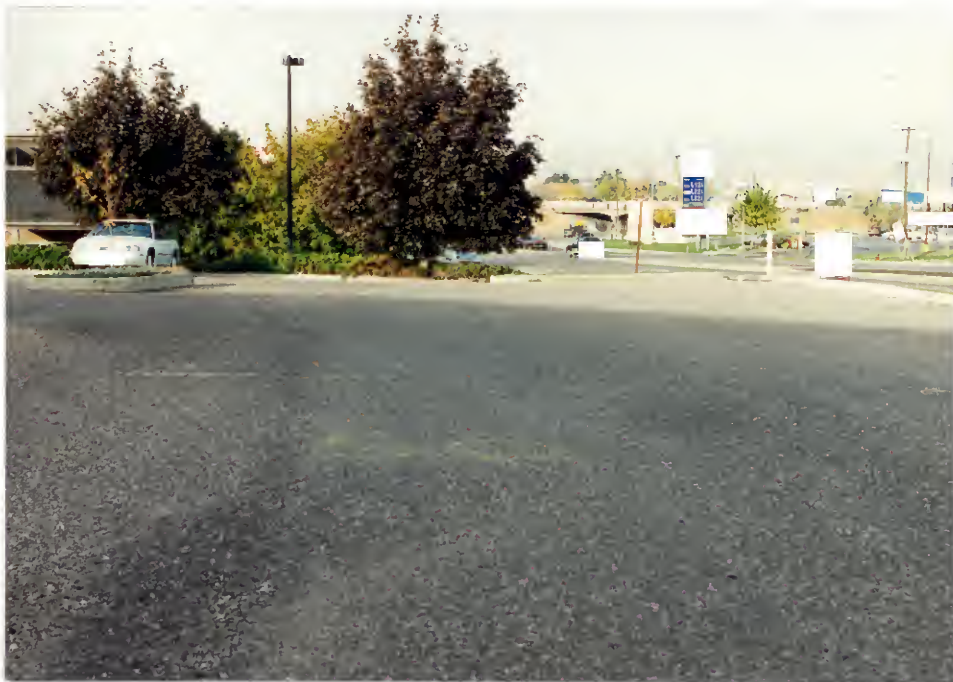
10. Trajectory of Vehicle #1 - 15.2 m (50.0') prior to the point of impact (POI) and viewed from the restaurant driveway.

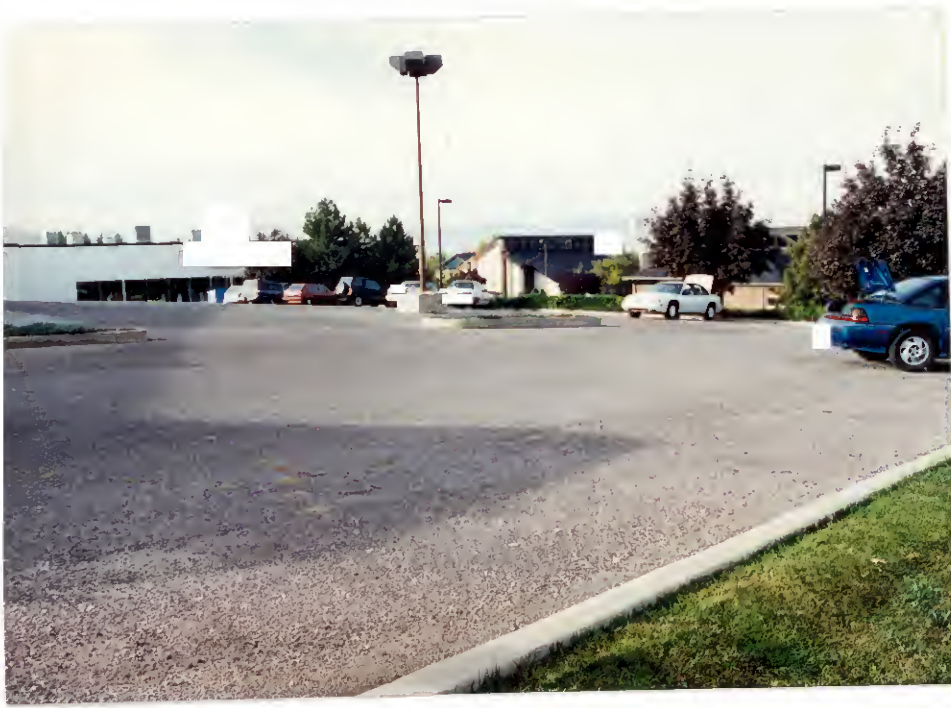
11. Trajectory of Vehicle #1 - 15.2 m (50.0') prior to the point of impact (POI) and viewed from between the four lane divided roadway and the restaurant driveway.

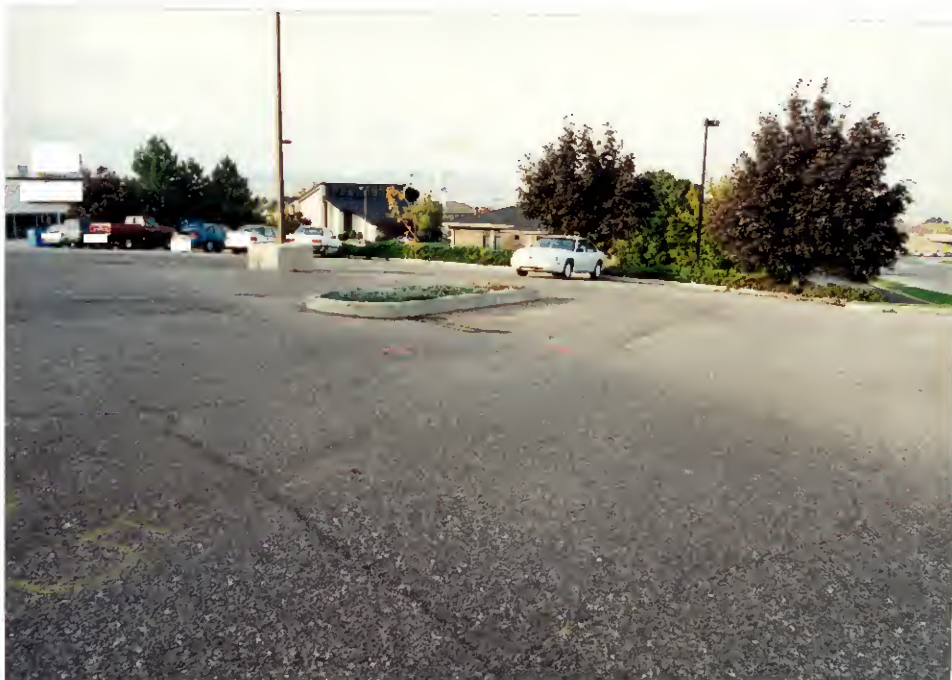
12. Trajectory of Vehicle #1 - 7.6 m (25.0') prior to the point of impact (POI) with the curbed parking lot island.

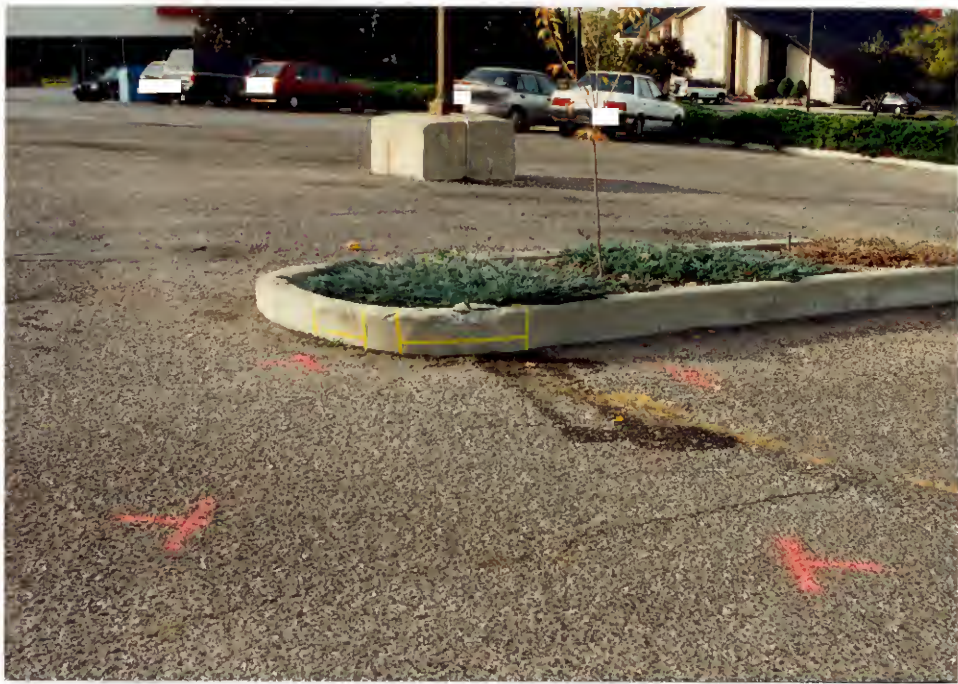
The rack and pinion housing immediately to the left of the skid plate and extending to the left 13.0 cm (5.1") also contacted the concrete curb. This contact fractured the housing and displaced the left side of the steering rack 3.8 cm (1.5") upward and rearward. Power steering fluid was released through the fracture site and was visible on the asphalt at the scene (refer to photographs #13-#14 on page A-7, #53 on page A-27).

13. Trajectory of Vehicle #1 showing the POI with the parking lot island curb.

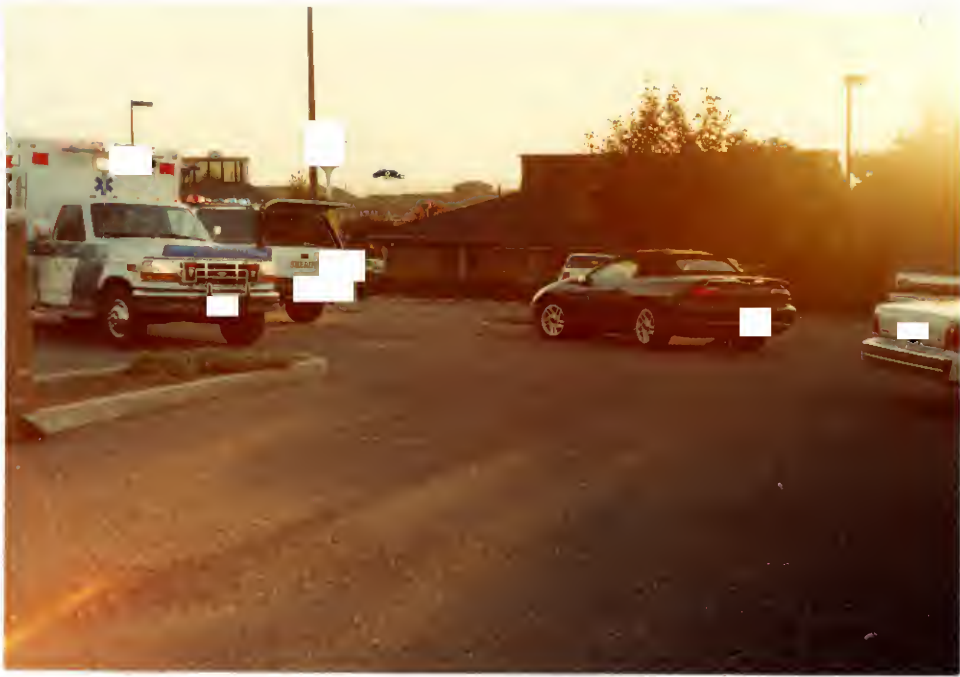
19. On-scene police photograph of Vehicle #1's final rest position (FRP) taken along its precrash direction of travel.

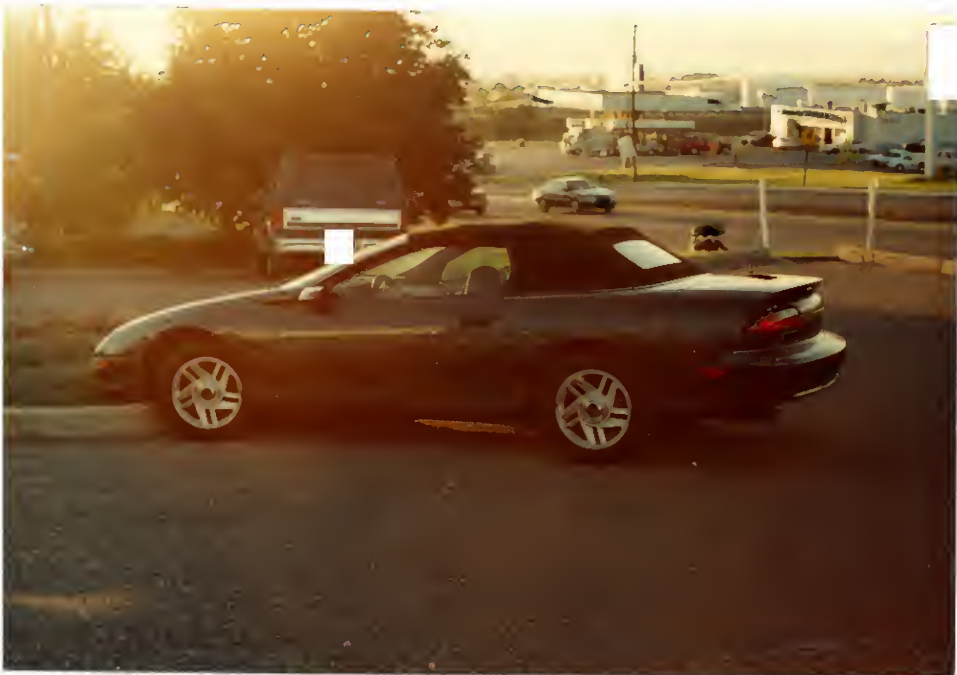
20. On-scene police photograph of Vehicle #1 at the FRP.

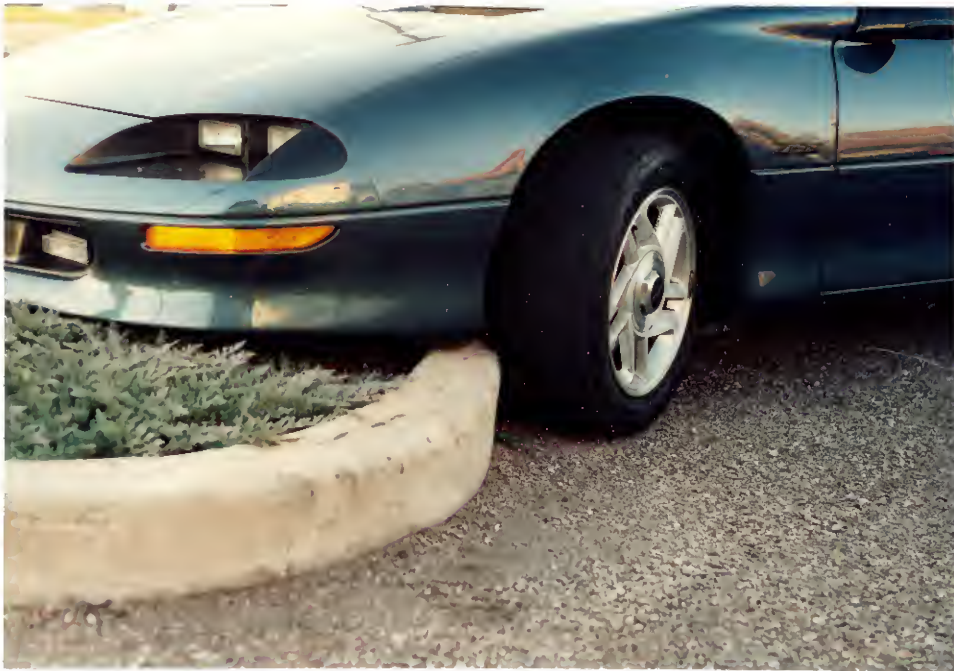
21. On-scene police photograph of the left front corner of Vehicle #1 at the FRP.

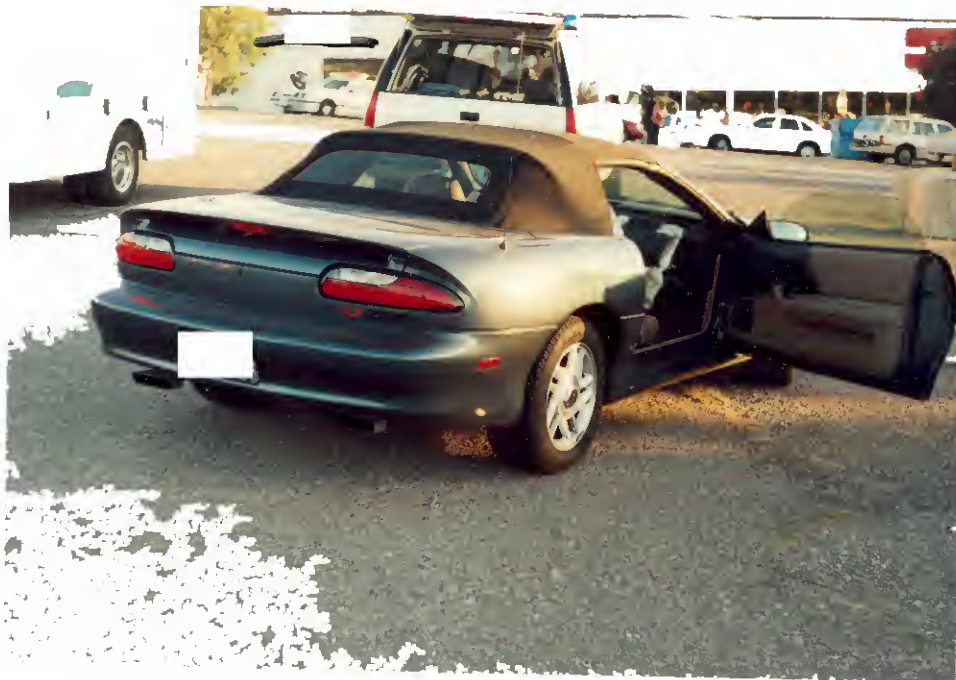
23. On-scene police photograph of Vehicle #1 at the FRP looking in a southerly direction.

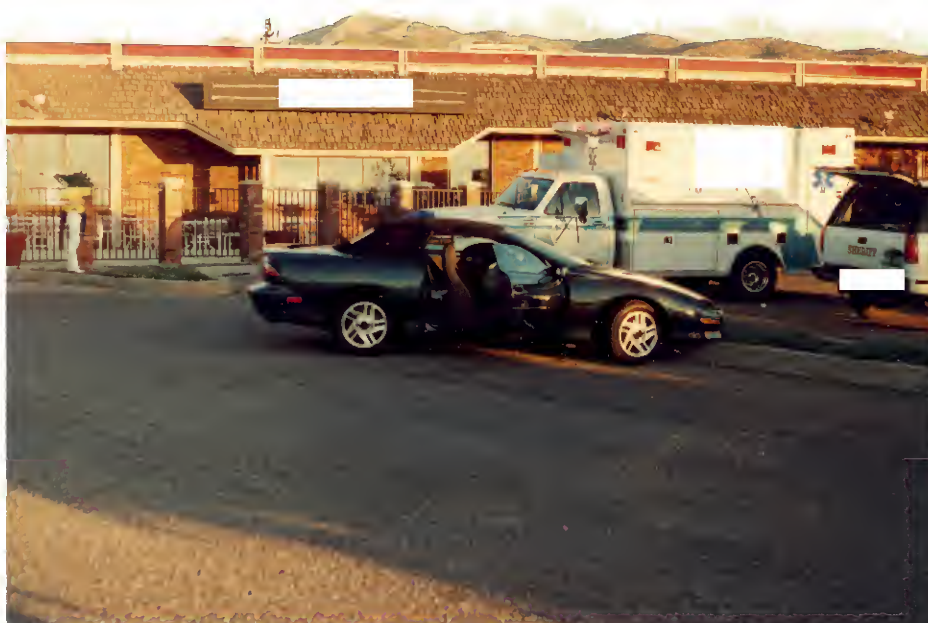
24. On-scene police photograph of Vehicle #1 at the FRP.

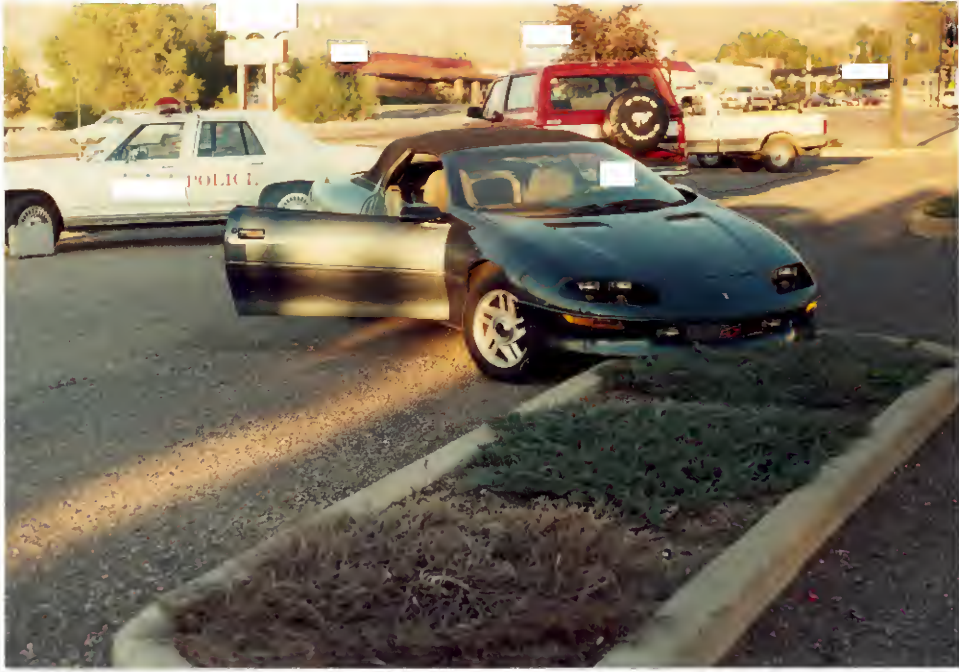
25. On-scene police photograph of Vehicle #1 at the FRP looking in the reverse direction of pre-impact travel.

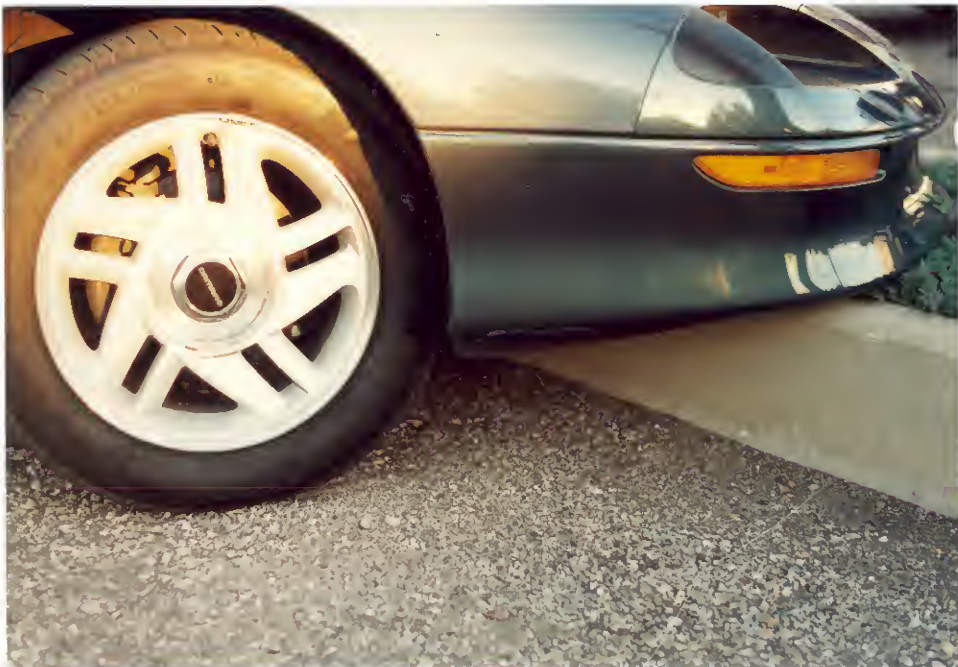
26. On-scene police close-up photograph of Vehicle #1's right front tire and fender at the FRP.

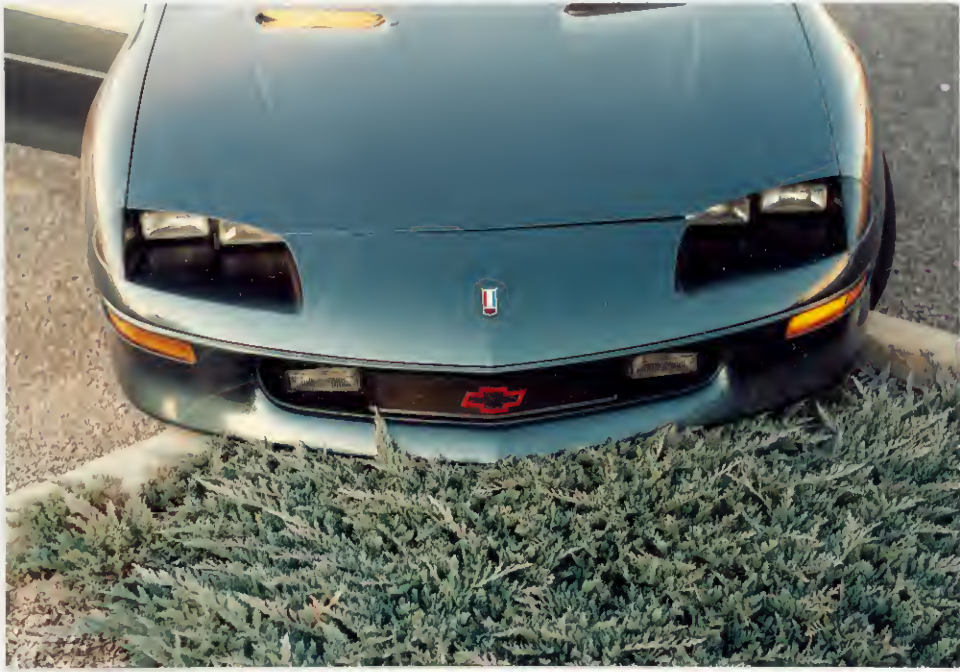
27. On-scene police photograph of Vehicle #1's frontal plane at the FRP.

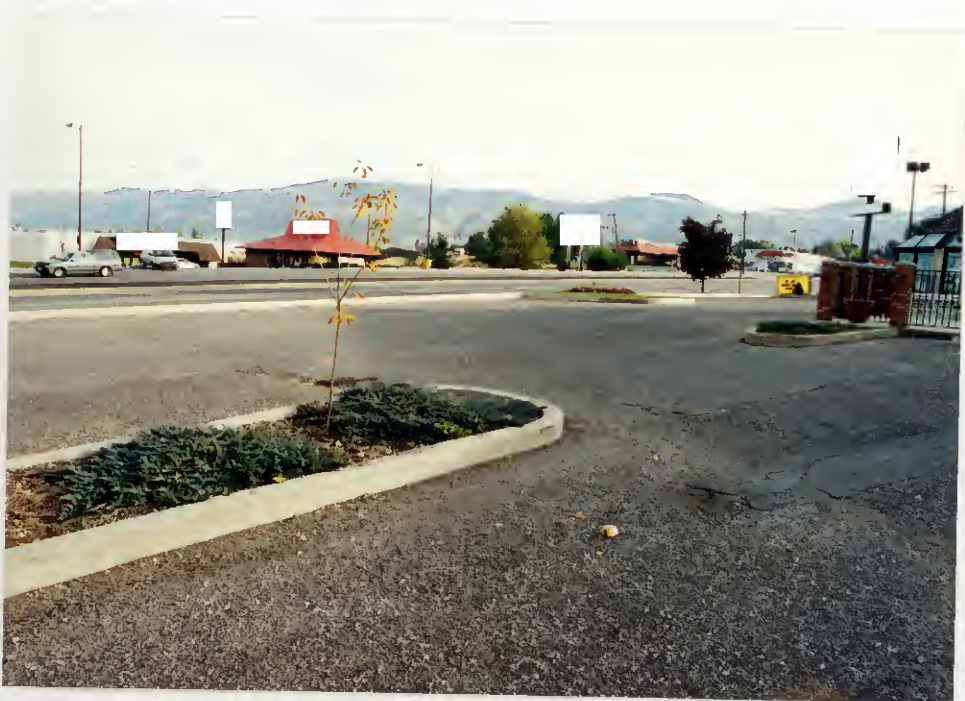
28. Reverse view of the FRP looking longitudinally through the center of Vehicle #1's lateral axis.

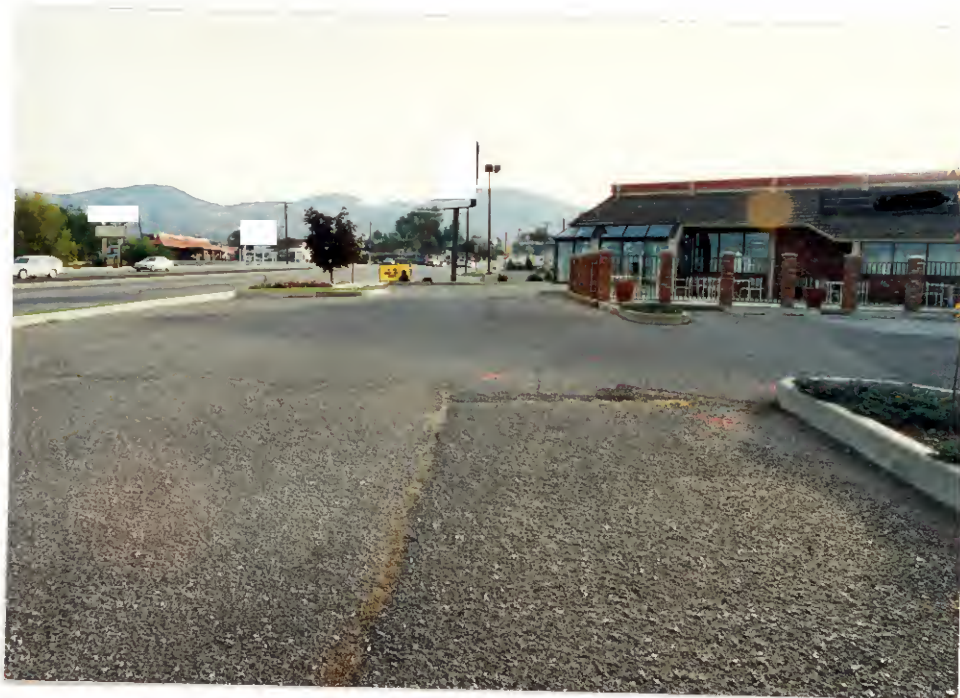
29. Reverse view of Vehicle #1's pre-impact trajectory from a point west of the FRP.

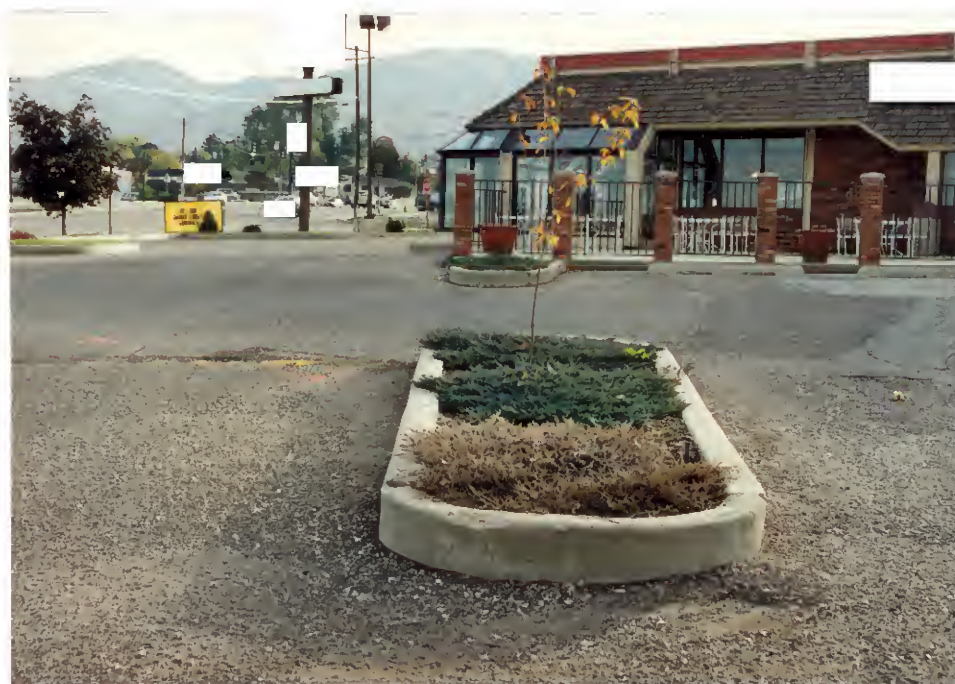
30. Reverse view of Vehicle #1's pre-impact trajectory from a point west of the FRP along the parking lot island curb. Note the relative location of the parking spaces in the background near the building to the POI which were the intended destination of the driver.

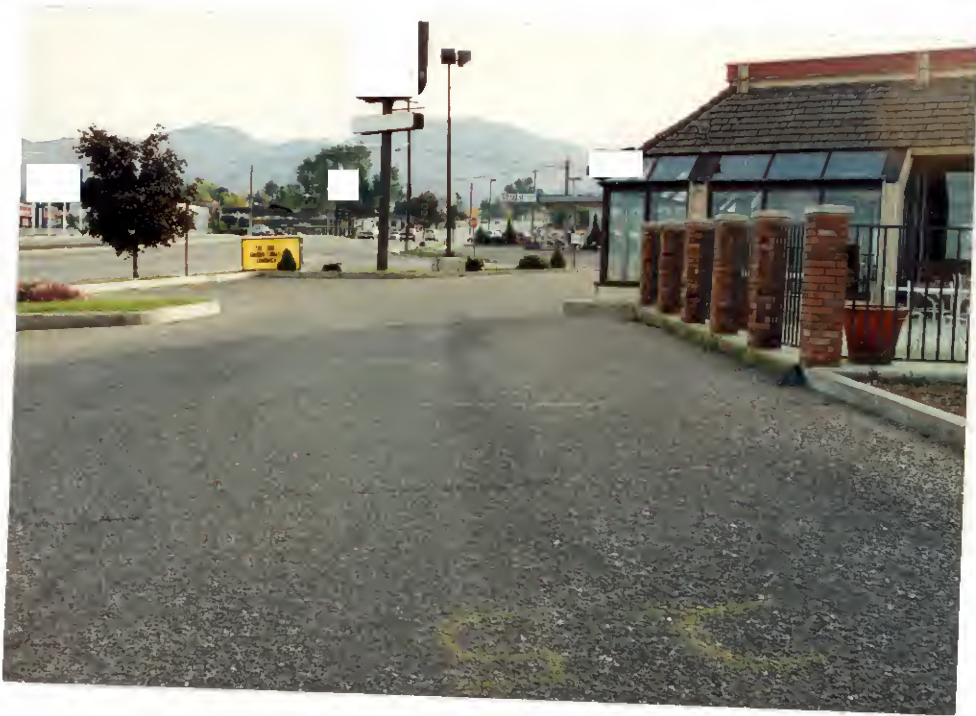
31. Reverse view of Vehicle #1's pre-impact trajectory from a point 7.6 m (25.0') east of the FRP.

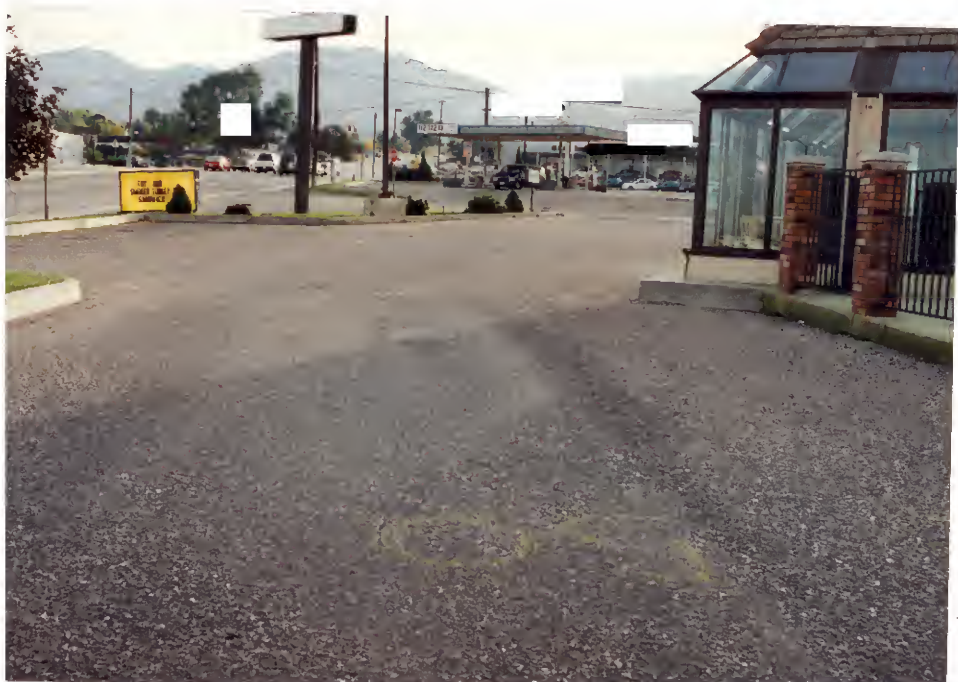
32. Reverse view of Vehicle #1's pre-impact trajectory from a point 15.2 m (50.0') east of the FRP.

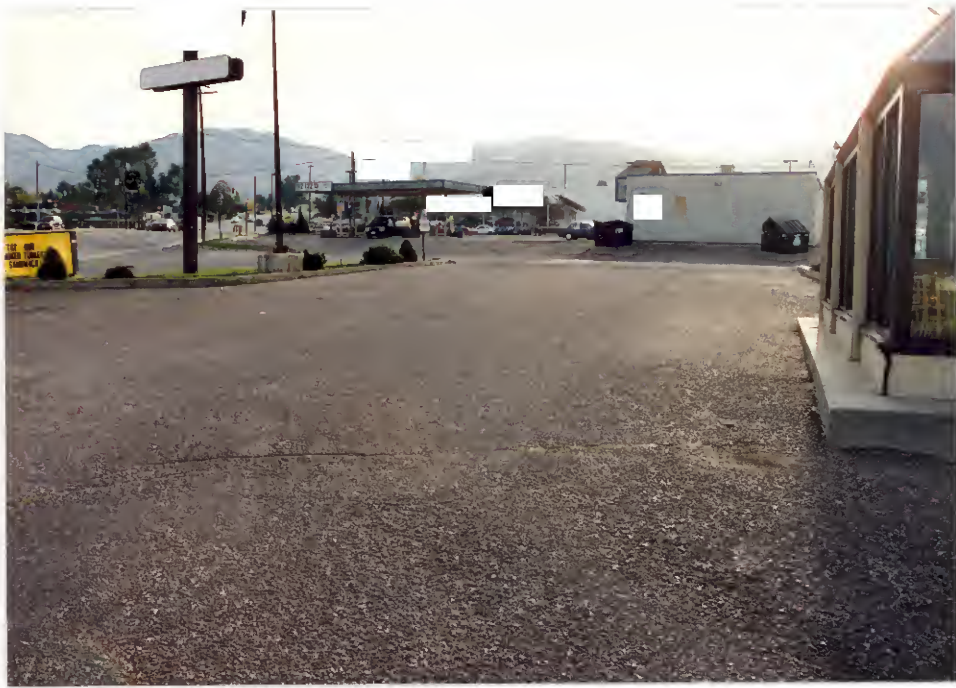
33. Reverse view of Vehicle #1's pre-impact trajectory from a point 22.9 m (75.0') east of the FRP.

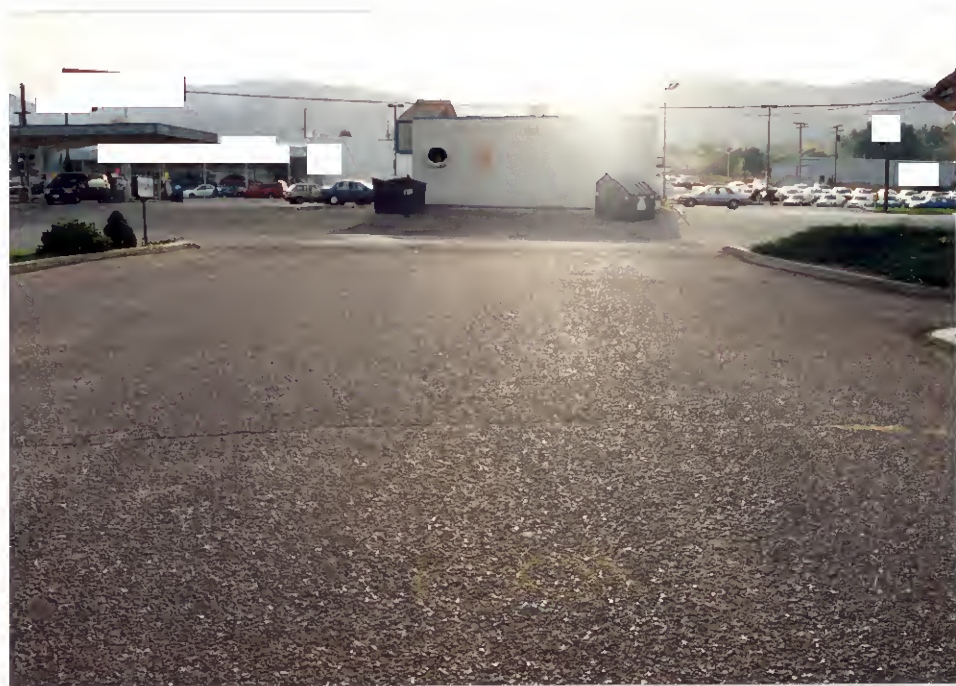
34. Reverse view of Vehicle #1's pre-impact trajectory from a point 30.5 m (100.0') east of the FRP.

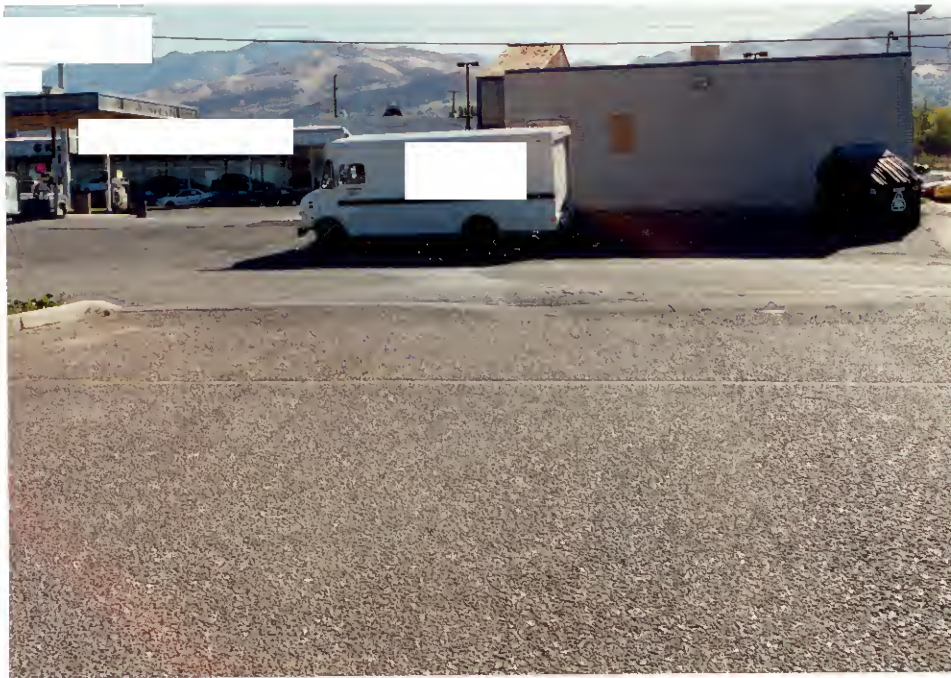
35. Reverse view of Vehicle #1's pre-impact trajectory from a point 45.7 m (150.0') east of the FRP.

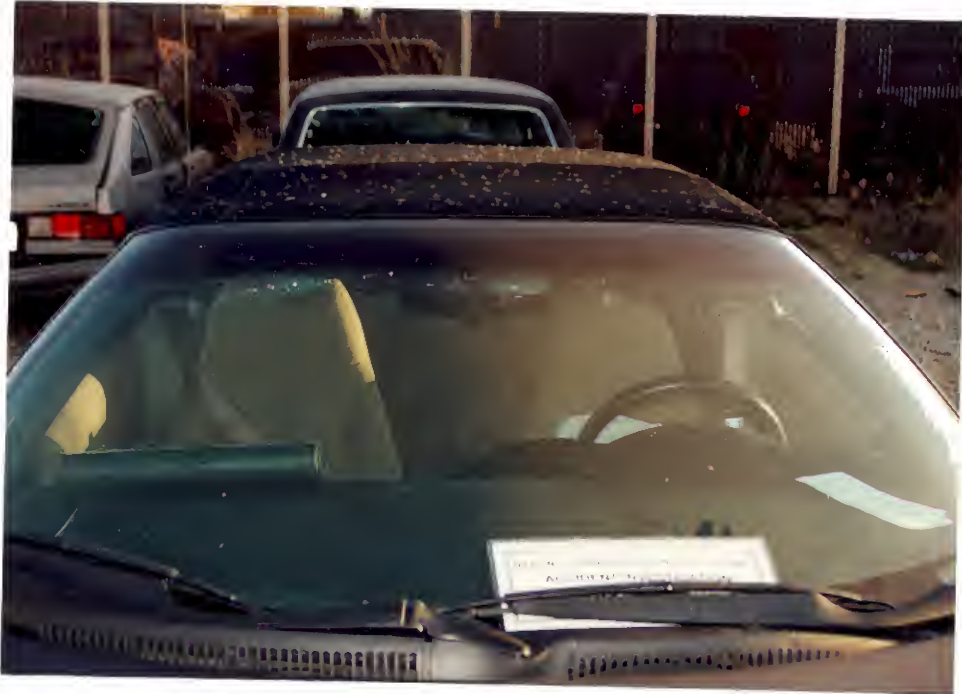
38. Frontal view of Vehicle #1.

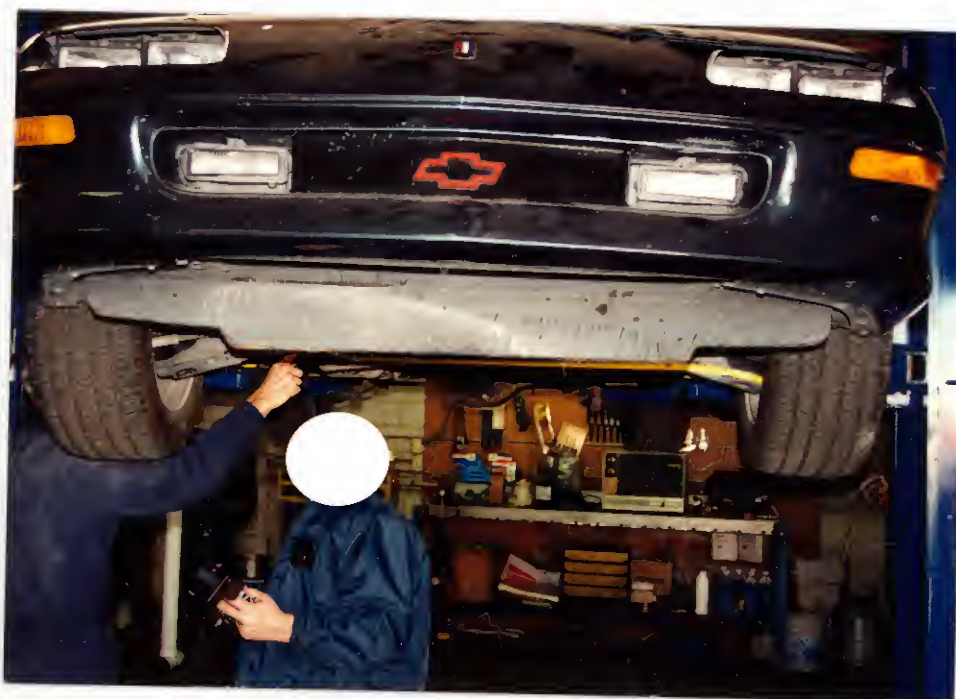
48. Another view of the front air dam with the vehicle raised in the air.

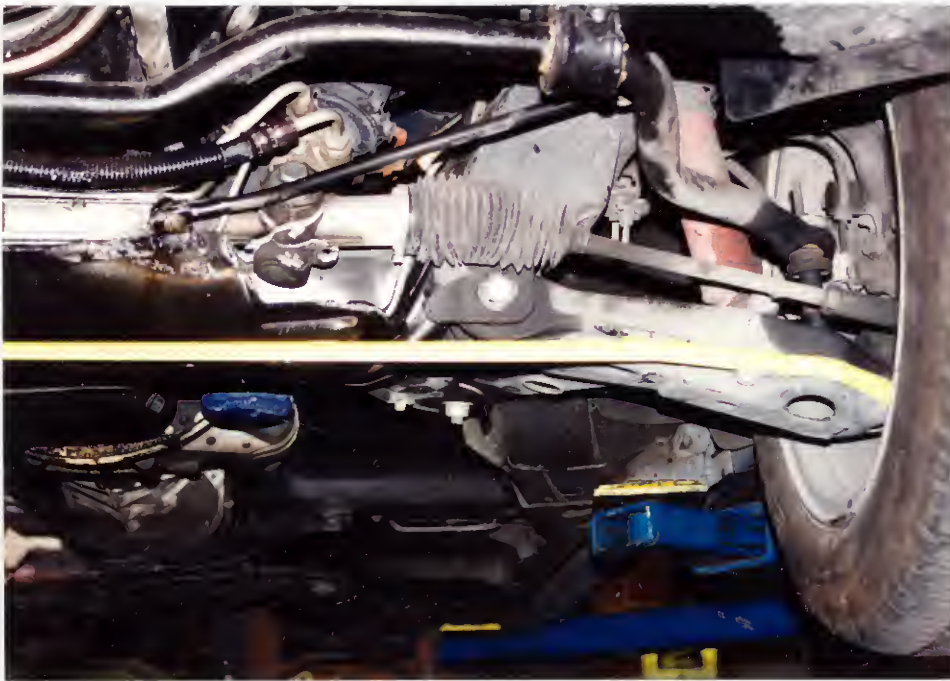
51. Another view of the skid plate and the rack and pinion power steering housing.

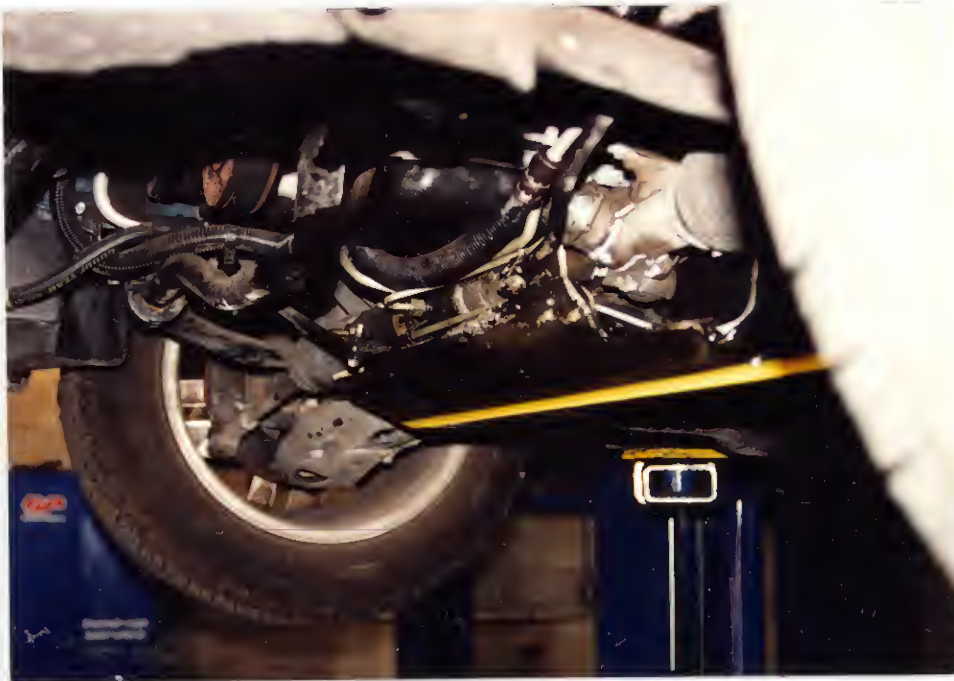
52. Angular view of damaged undercarriage components as seen from the left side of the vehicle.
